STATE OF CALIFORNIA  
DEPARTMENT OF WATER RESOURCES  
DIVISION OF RESOURCES PLANNING

BULLETIN NO. 81

INTRUSION OF SALT WATER  
INTO GROUND WATER BASINS OF  
SOUTHERN ALAMEDA COUNTY

December 1960

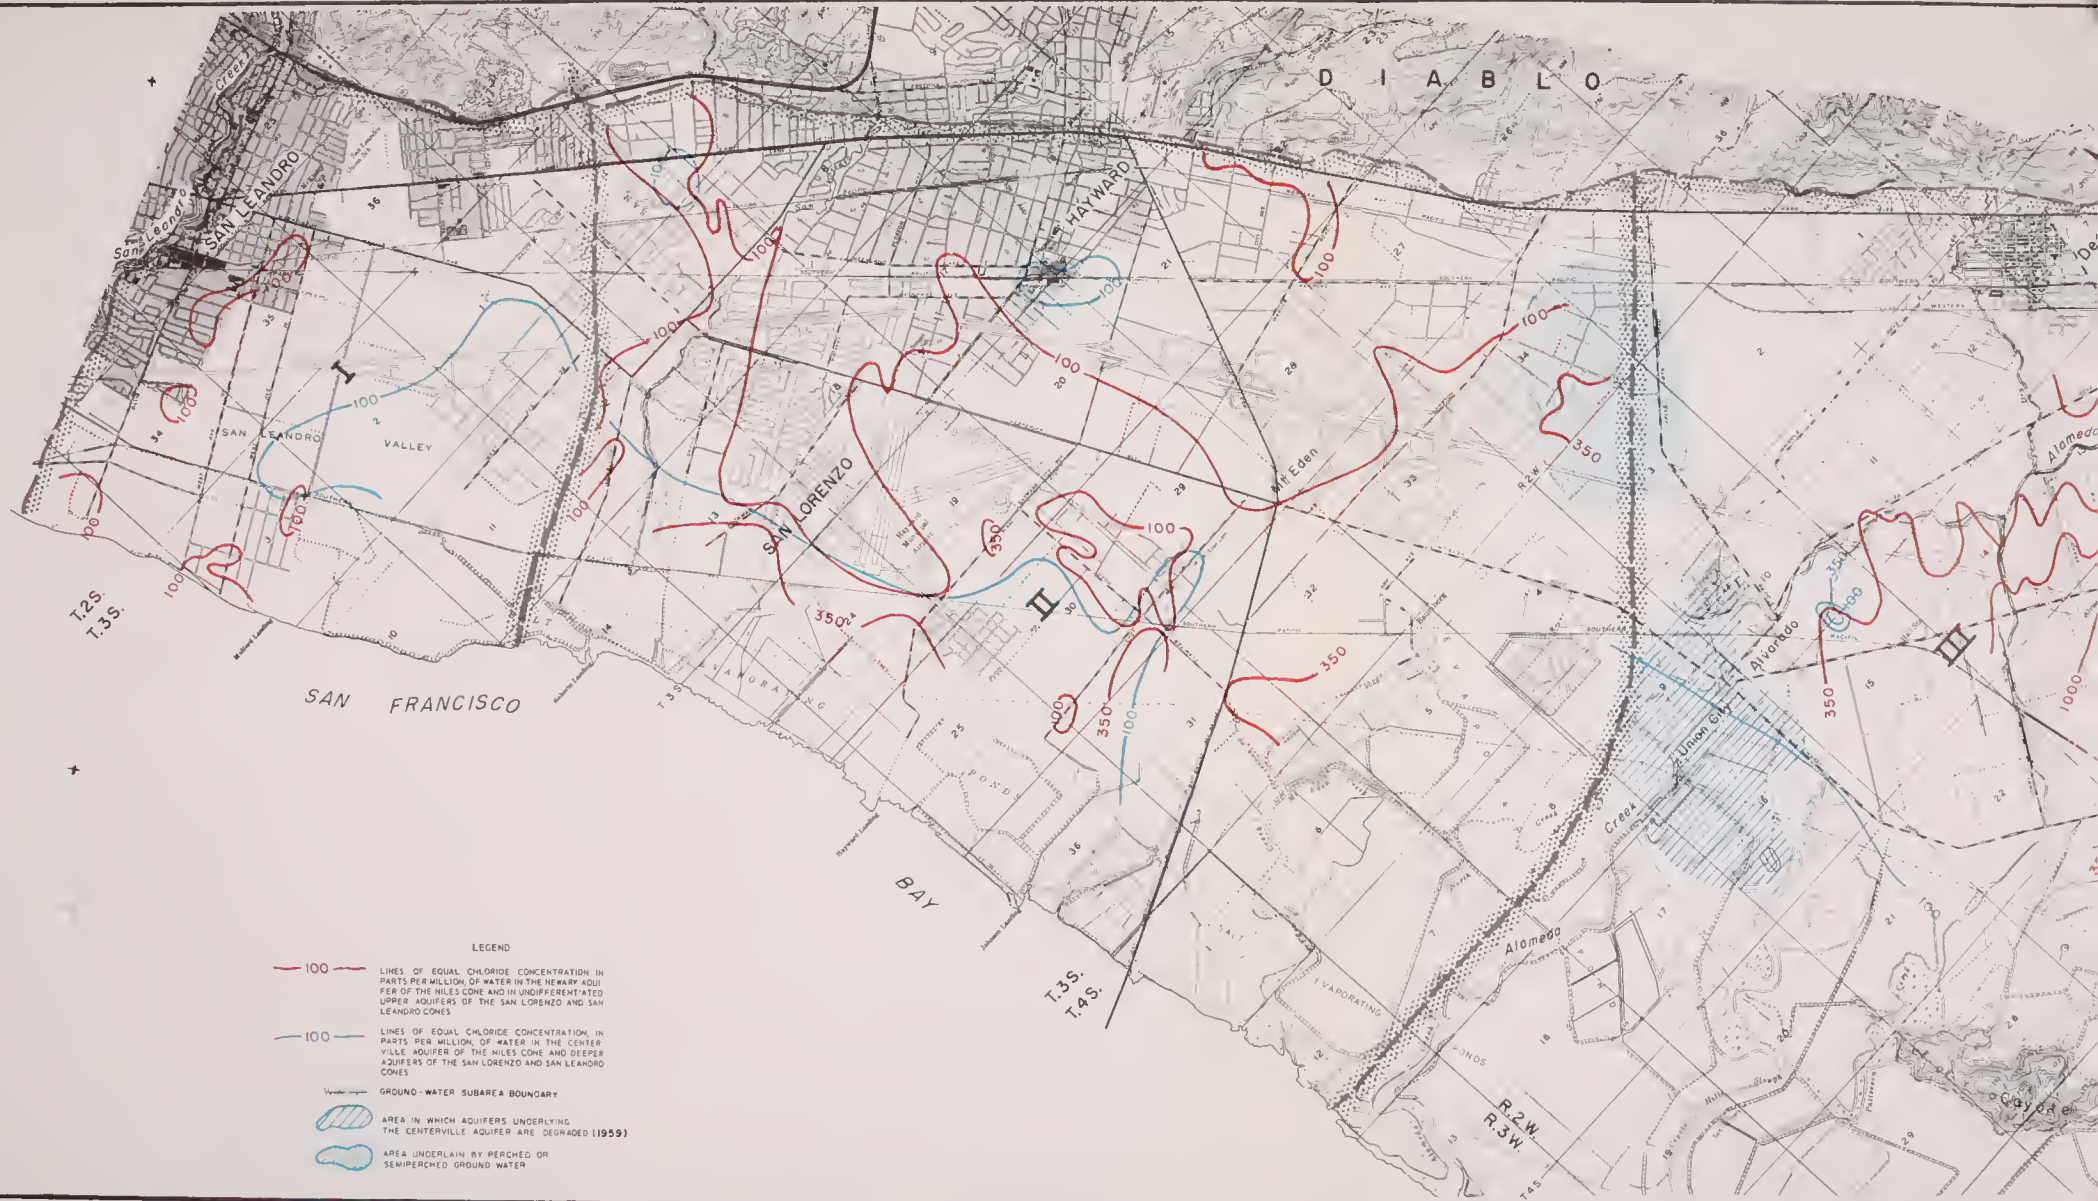
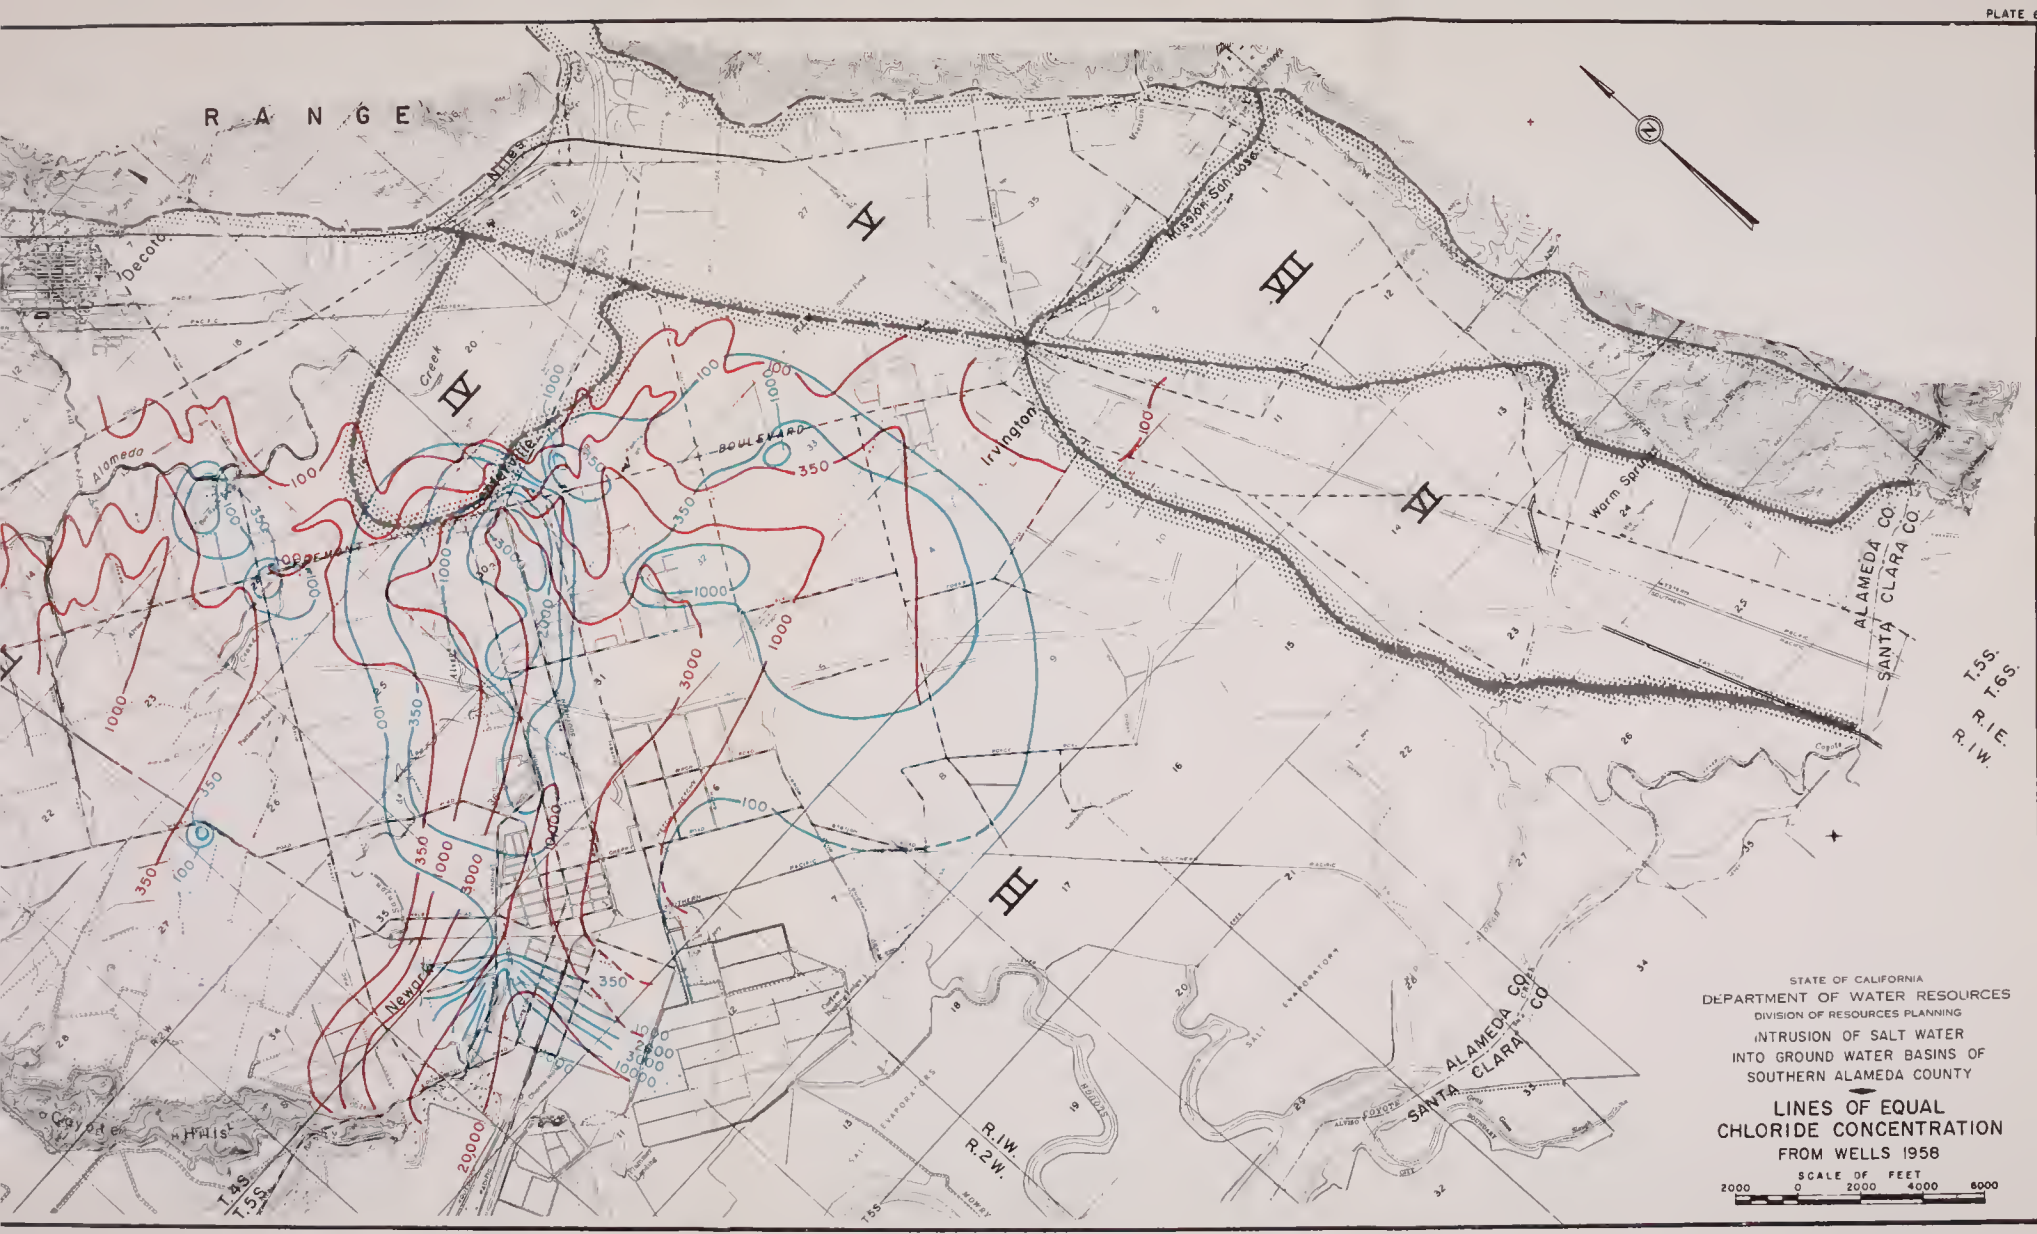
STATE OF CALIFORNIA  
 DEPARTMENT OF WATER RESOURCES  
 DIVISION OF RESOURCES PLANNING  
 INTRUSION OF SALT WATER  
 INTO GROUND WATER BASINS OF  
 SOUTHERN ALAMEDA COUNTY  
**LINE OF EQUAL  
 CHLORIDE CONCENTRATION**  
 FROM WELLS 1958

By late 1958, about 2,630 acres of the Centerville aquifer were affected (Plate 6). Samples collected during 1959 show that about 3,000 acres were degraded by salt water.

Plate 6 shows an isolated area in the vicinity of Alvarado and Newark where water of the Fremont aquifer was found to be degraded in 1959. It is important to note that degradation of this aquifer has begun.

Spill Over Inland Edge of Confining Clay Layer. The area affected by salt-water intrusion in the Centerville aquifer, as shown on Plate 6, extends inland to the vicinity of Fremont Boulevard. If this degradation were caused by spill of saline waters from the Newark aquifer over the inland edge of the separating clay layer, it could be postulated that the clay layer should end in this vicinity. To test this hypothesis, an investigation was conducted to determine whether the clay layer was present in this area.
